RE: March 2005 Monthly Report
1.5 Mile Reach Removal Action
GE-Pittsfield/Housatonic River Site

Figure 1
1.5 Mile Removal Action
Site Map (Map 1 of 2)
March 2005 Monthly Report

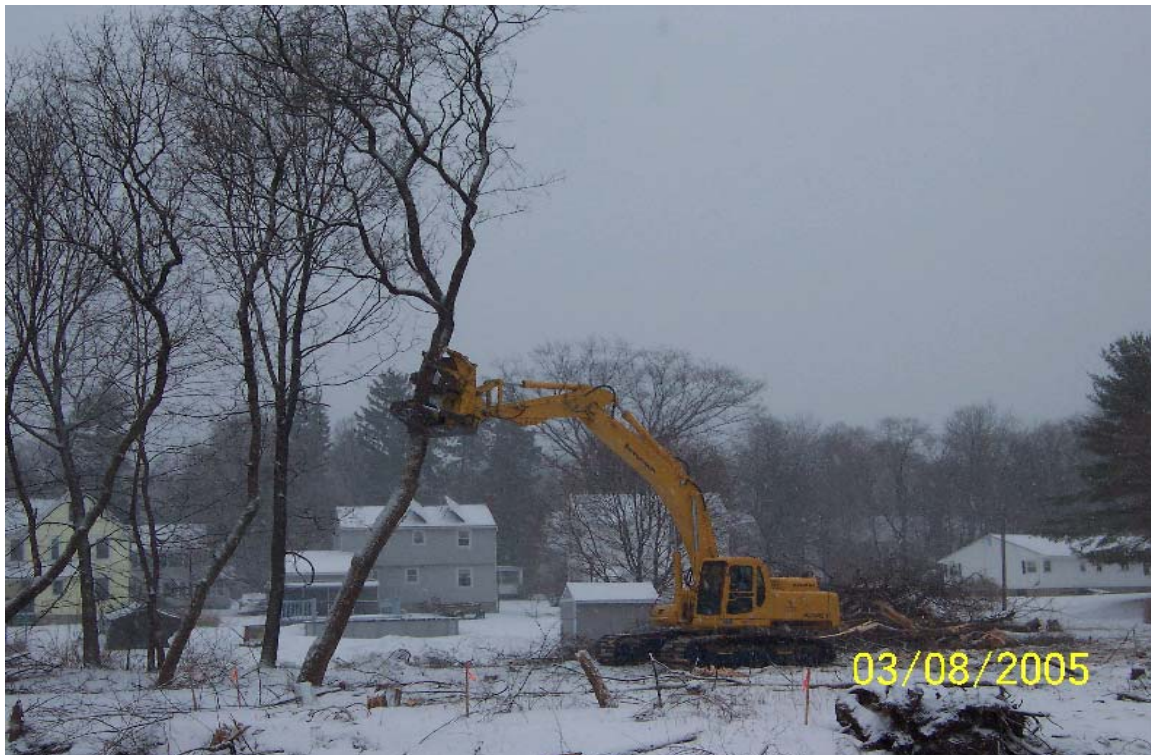
Photograph 1 – Tree Clearing Activities for the Staging Area at Parcels I7-3-5, I7-3-6, and I7-3-7

Tree clearing and grubbing activities on Parcels I7-3-4, I7-3-5, I7-3-6, and I7-3-7 (the location of the access road and staging/support areas for Phase 3B) was completed. Tree and brush debris was moved to GE Newell Street parking lot for future chipping. Also, an access road was constructed on Parcel I7-3-6 connecting Appleton Avenue to the staging/support area. The road was built by using geotextile filter stone and dense grade/airport mix material. The construction of the staging/support area on Parcels I7-3-4, I7-3-5, I7-3-6, and I7-3-7 was initiated. The staging/support area will be built by installing a layer of geotextile followed by a layer of dense grade/airport mix material.

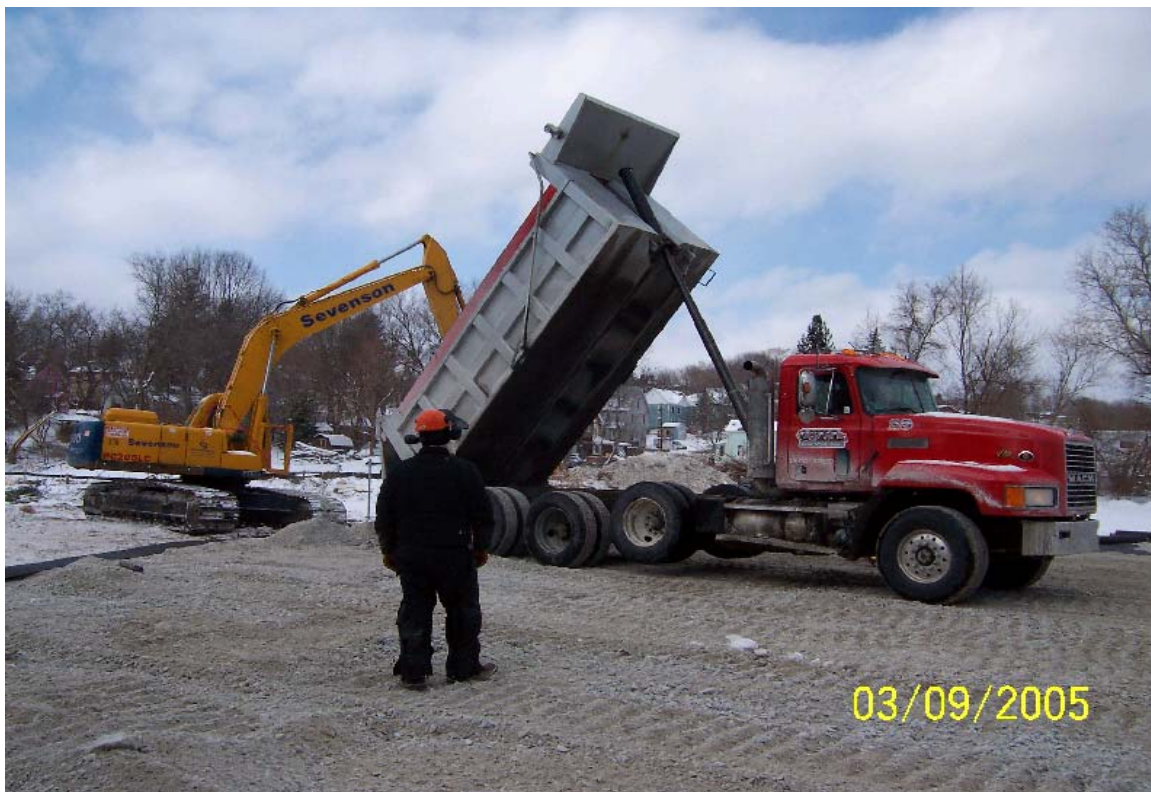
Photograph 2 – Construction of the Staging Area at Parcels I7-3-5, I7-3-6, and I7-3-7

The construction of the staging/support area on Parcels I7-3-4, I7-3-5, I7-3-6, and I7-3-7 was completed. The delivery, assembly and testing of the 200-pound crane was completed. The relocation of the sheetpile, the sheetpile driving frame and the sheetpile driving equipment from the GE Lyman Street staging area to the staging/support area on Parcels I7-3-5, I7-3-6, and I7-3-7 was initiated.

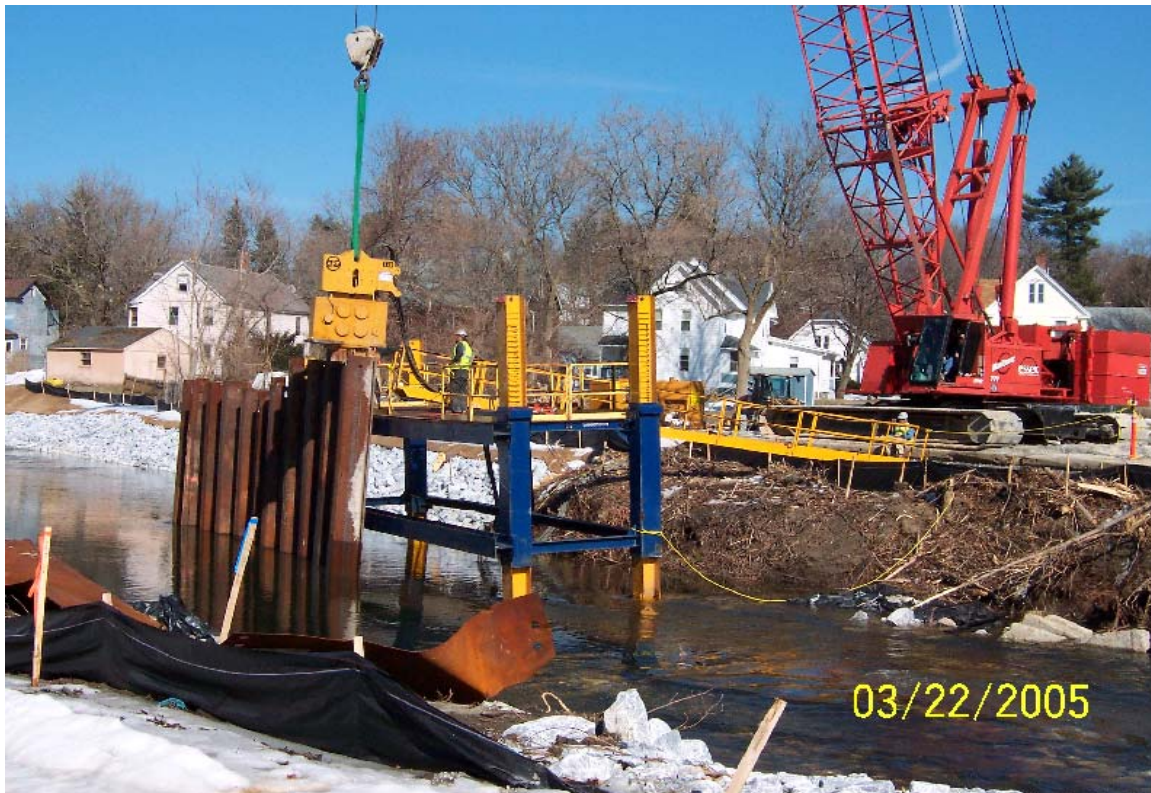
Photograph 3 – Installation of the Centerline Sheetpile Wall for Cells 25 and 26

The survey contractors delineated and staked out the centerline of the river channel in Cells 25 and 26 and the installation of the centerline sheetpile wall between Cells 25 and 26 was initiated. The relocation of the sheetpile from the from the GE Lyman Street staging area to the staging/support area on Parcels I7-3-4, I7-3-5, I7-3-6, and I7-3-7 continued.

The installation of the centerline sheetpile wall between Cells 25 and 26 continued.

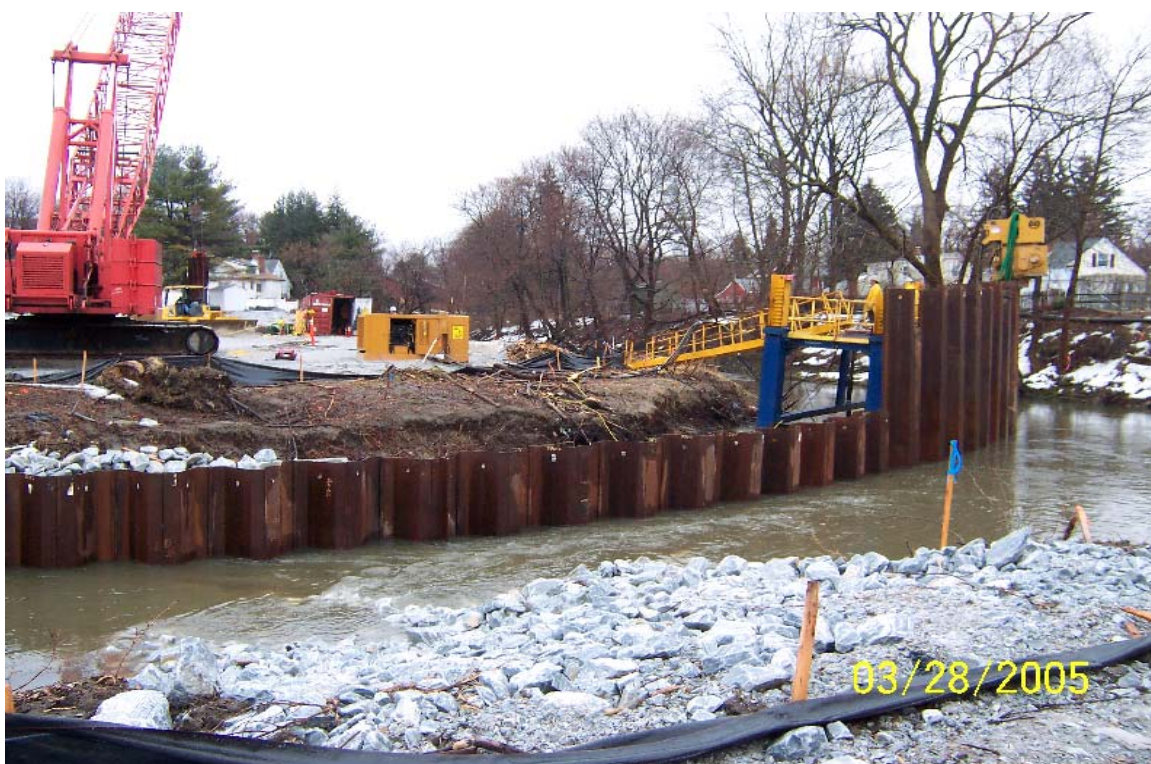
Photograph 4 – Installation of the Centerline Sheetpile Wall for Cells 25 and 26

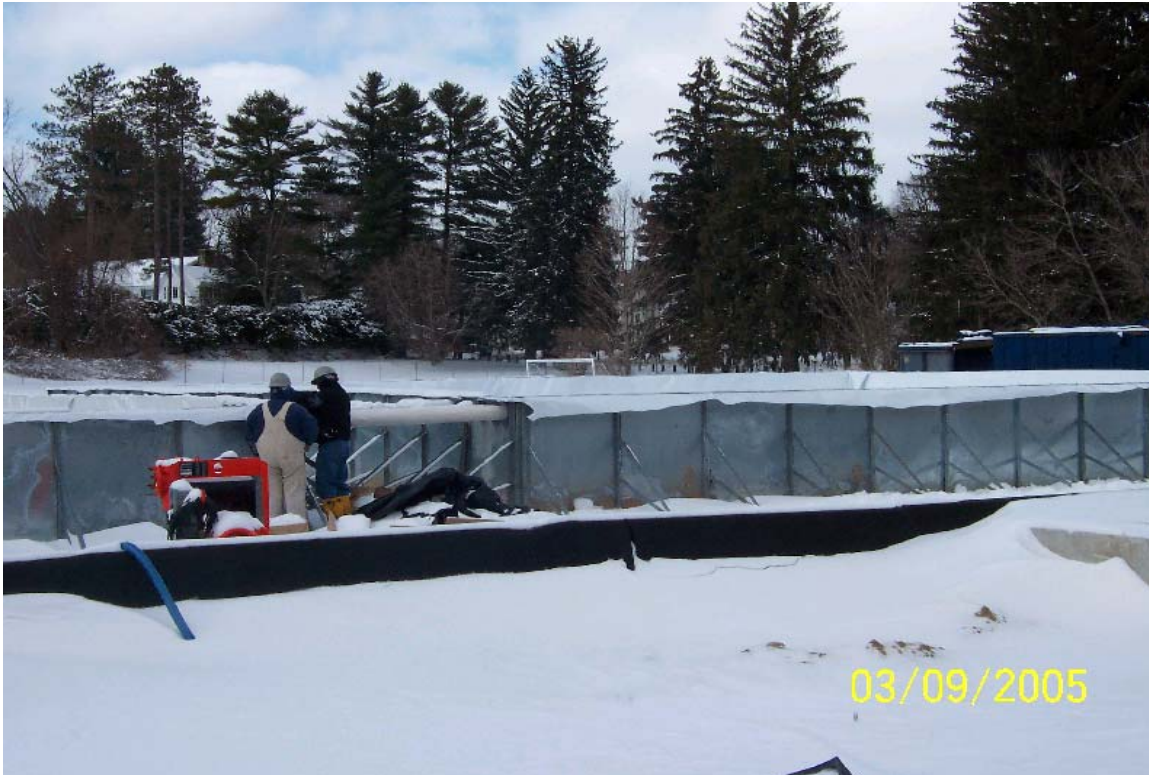
Photograph 5 – Construction of the Water Treatment System Modutanks at Fred Garner Park

During the second week of March, activities associated with the set up of the WTS at the Fred Garner Park continued. The construction of the WTS modutanks was completed and the set up of the WTS electrical components continued. Carbon was installed into the WTS carbon filter vessels. The welding and installation of the 8-inch force main for the WTS was initiated.

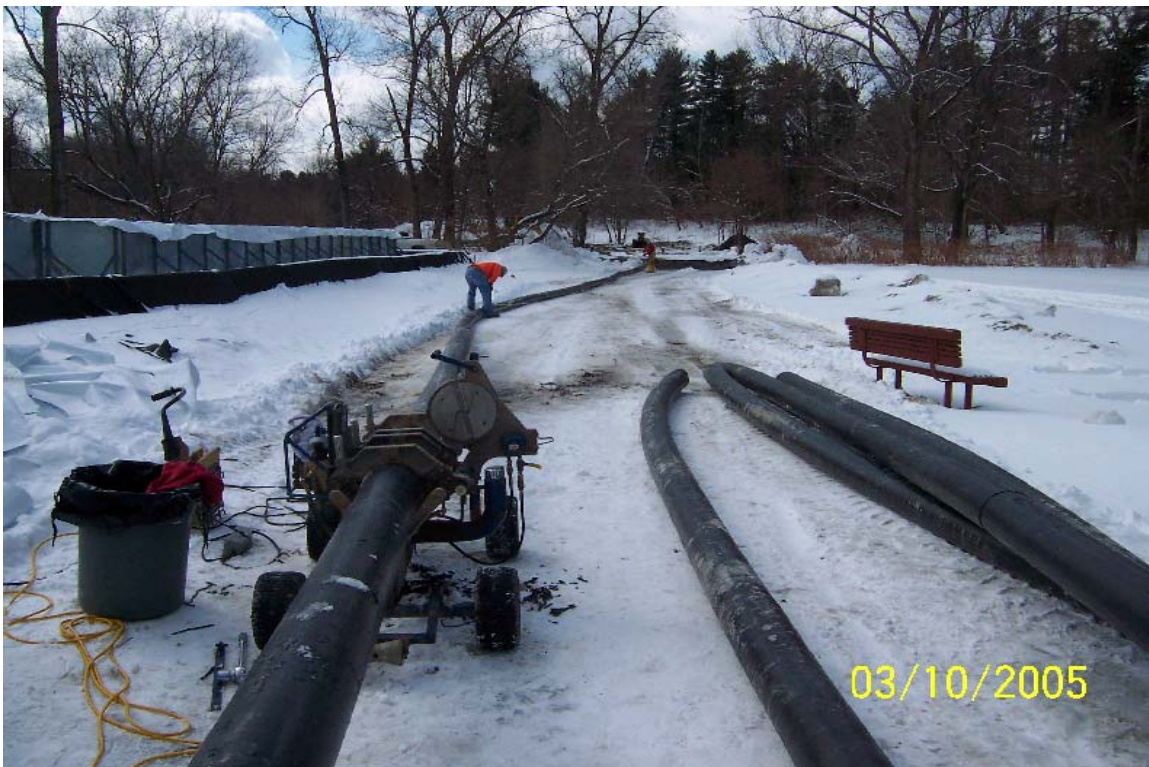
Photograph 6 – Welding of the 8-inch Force Main for the Water Treatment System

During the last week of March, activities associated with the set up of the WTS at the Fred Garner Park continued. The set up of the WTS piping and the electrical components continued. The testing of the 8-inch force main for the WTS by pressurizing the line with air was

completed. A small leak was found at a flange joint during the test that required tightening of the flange joint.
